The National Organization of Exterior Finish System Inspectors™

PREVENTING OR REPAIRING DAMAGE TO COMPOSITE SIDING

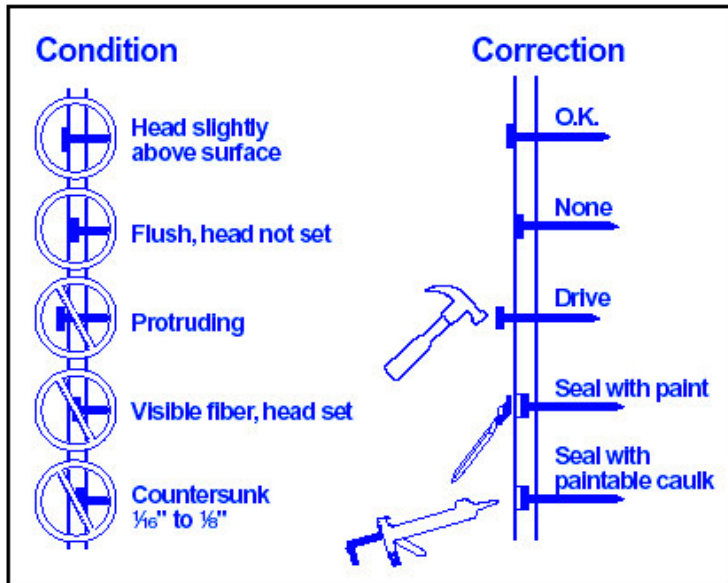
FIG 1 COMMONLY ENCOUNTERED CONDITIONS AT FACE NAILS AND THE RECOMMENDED REPAIRS

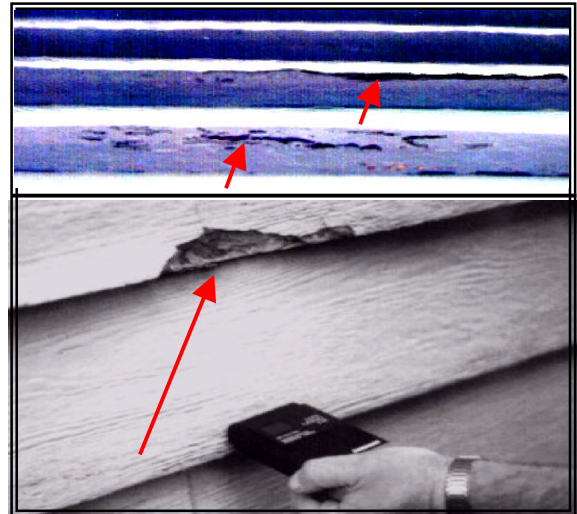
Fig 2 the delamination and edge checking shown at the top has reached the danger level. The deterioration shown at the bottom will soon follow if the siding is not repaired.

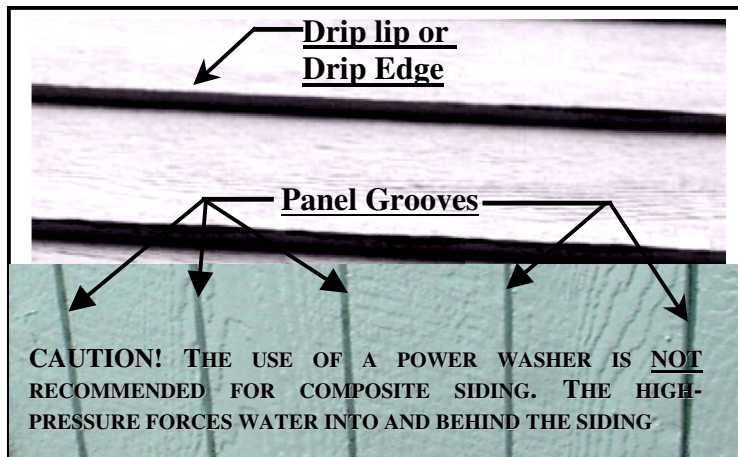
Fig 3 A significant amount of the damage found in composite siding occurs at the bottom drip lip of lap siding or the grooves in panel siding.. The problems start when this edge or groove is not backbrushed with an added layer of paint. As the paint on this edge or groove begins to fail, moisture penetrates into the substrate and causes it to swell. This causes more paint failures, which then allows more moisture into the substrate, which starts the cycle over again. With each new cycle the amount of damage increases.

To begin preventing or repairing damage to the drip lip or panel grooves, wash the siding with a solution of 2/3 cup of TSP (tri-sodium phosphate) and 1 pint of household bleach dissolved in 1 gallon of water. Rinse the siding and apply the cleaning solution to the walls while they are still wet. The cleaner can be easily applied using a stiff push broom dipped into a wallpaper tray. Allow the cleaner to stand for 10 to 15 minutes before thoroughly rinsing with a garden hose. A second application may be necessary in some areas.

Allow the siding to dry thoroughly before proceeding.

The next step is to seal the drip lip or grooves:

Use either a compatible penetrating or elastomeric sealer (such as Aquathon by United Coatings) or a Block Filler (such as Miller Paint's Product 6015).

Apply liberally with a paintbrush on every drip lip or groove. A second coat may be necessary here as well. The last step is to apply 2 coats of a compatible 100% acrylic latex paint. Backbrushing is again important because, as you remember, the problems started because the drip lip or grooves were not backbrushed.
